## Failure Analysis

### Rochon Engineering Incorporated's Metallurgical Investigations Expose the Facts

# ROCHON REPORT

Volume 2 Issue 111

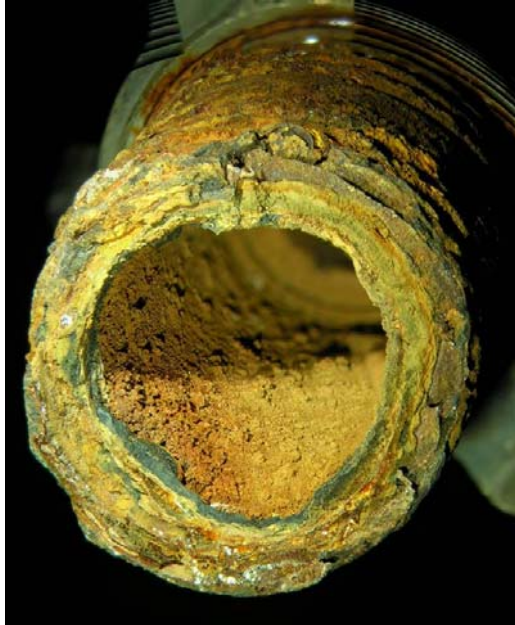
**Galvanic corrosion failure of a steel pipe nipple interconnecting two stainless steel fittings**

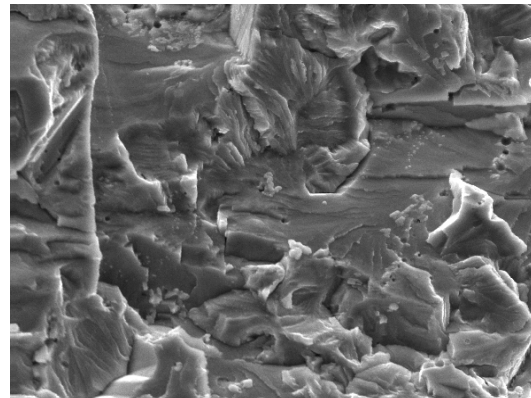
**SEM micrograph showing cleavage fracture caused by stress corrosion cracking due to the dezincification of brass and resulting brittle failure of a water fitting**

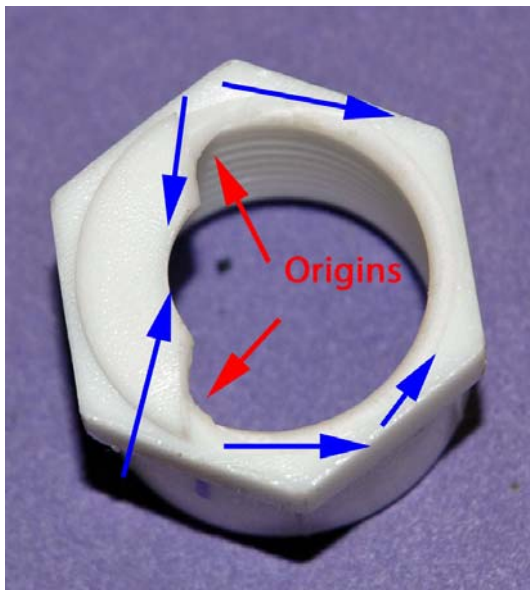
Some \$5 toilet water supply fittings undergo delayed fracture of the plastic ballcock fitting resulting in costly water damage claims. One design has a material defect caused during the plastic injection moulding process.

**Failed toilet water supply fitting with defects at fracture origins and fracture directions identified**

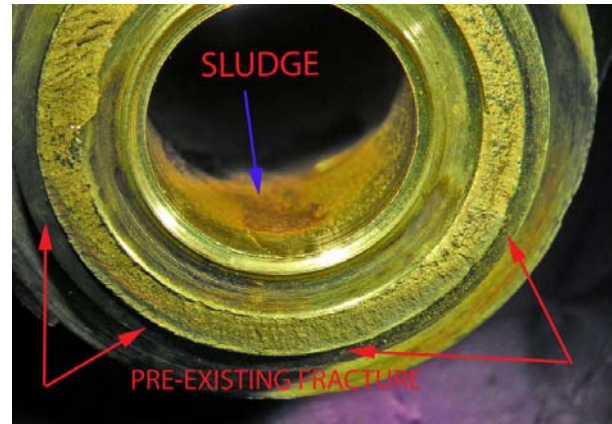
The failure of a fuel oil fitting that resulted in an oil spill was determined to have a pre-existing

crack caused by a bending load due to settlement of the tank.

**Failure of a fuel oil fitting with a pre-existing crack identified. Its orientation could be determined by sludge deposits indicating loading was from below**

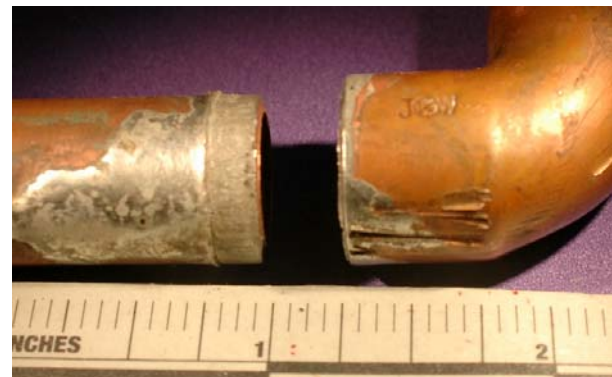
Water escape occurred in a high-rise building due to the improper fitment of a hot water heating pipe. The pipe was not fully seated into the cup of the elbow and tension from bending the pipe to fit caused a delayed separation.

**Separation of soldered pipe joint due to insufficient insertion into cup**
